MACHINE SERVICE BULLETIN NO. 257

SUBJECT: Carriage Shift of LA-5  
and LA-6 Machines

DATE: July 31, 1939

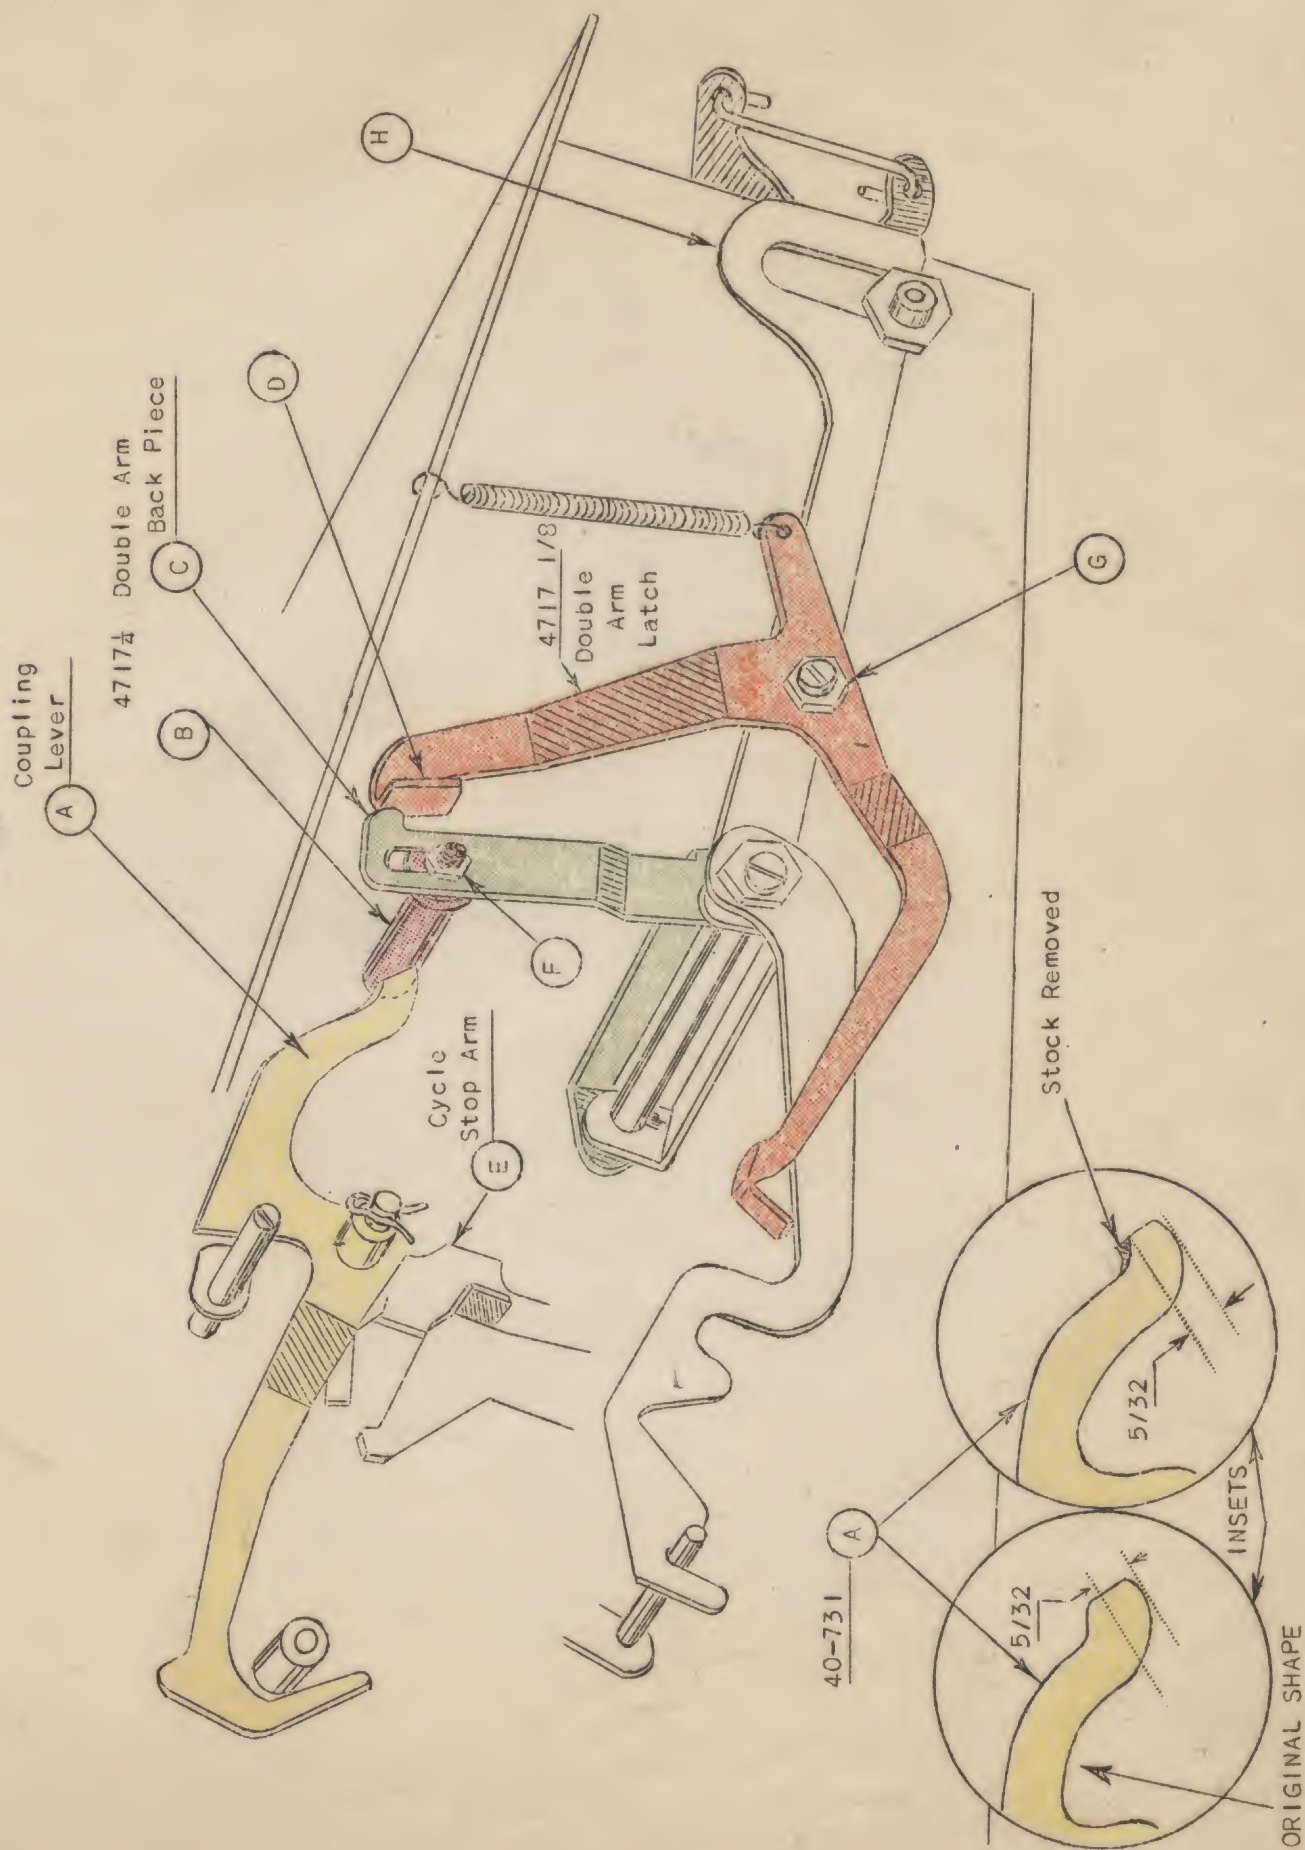
In order to obtain a satisfactory shift of the carriage on LA-5 and LA-6 model machines after all regular adjustments have been checked, servicemen have occasionally resorted to taking up on the clutch on the jack shaft until it failed to function as a slip clutch. To eliminate the need of such a practice, we suggest the removal of stock from the 40-731 coupling lever as illustrated on Plate 2 of this bulletin and the readjusting of the double arm latch 4717 1/8. Heretofore offset (D) was adjusted to (C) so that when the division lever was moved into operating position, (D) would latch under the step of (C) with as little excess clearance as possible and in order to insure the latching of (D) the 4717 1/8 was adjusted somewhat low. The natural result of this low adjustment was a loss of shift mechanism movement.

The journey of the cycle stop arm (E) to the bumper pad following an overcarry trip in minus, causes an idle movement of (A) in relation to (B), but following an over-carry trip in plus, (A) contacts and pushes (B) forward, causing a carriage shift.

To provide an upward adjustment of the 4717 1/8 by means of eccentric (G) without the possibility of it failing to latch under the step of (C) during the minus bumper stroke following an over-carry trip, stock could be removed from (A) as shown in the insets on Plate 2. The absence of this stock permits (C) to pivot rearward slightly more during the minus bumper stroke, thereby, allowing offset (D) to latch with (C) although the 4717 1/8 was adjusted higher than previously. Also, it is no longer necessary for (D) to latch under the step of (C) when the division lever is moved toward the carriage.

It will be interesting to note that after making this adjustment, (H) will be moved downward its entire distance before (A) starts to move under roller (B), thus proving that the grinding out of stock does not cause any loss of shift power.

After doing this it will be found that the slip clutch can be let out (friction reduced) considerably without retarding the carriage shift.

Roller (B) can be adjusted lower by loosening nut (F). However, its downward adjustment is limited due to interference with a stud on the machine stopping lever.
